SILVERTON

SERVICE BULLETIN

BULLETIN # 02-04

SUBJECT: Bow Rail Drains- 35, 39, and 43 Motor Yachts, 330 and 410 Sport Bridges

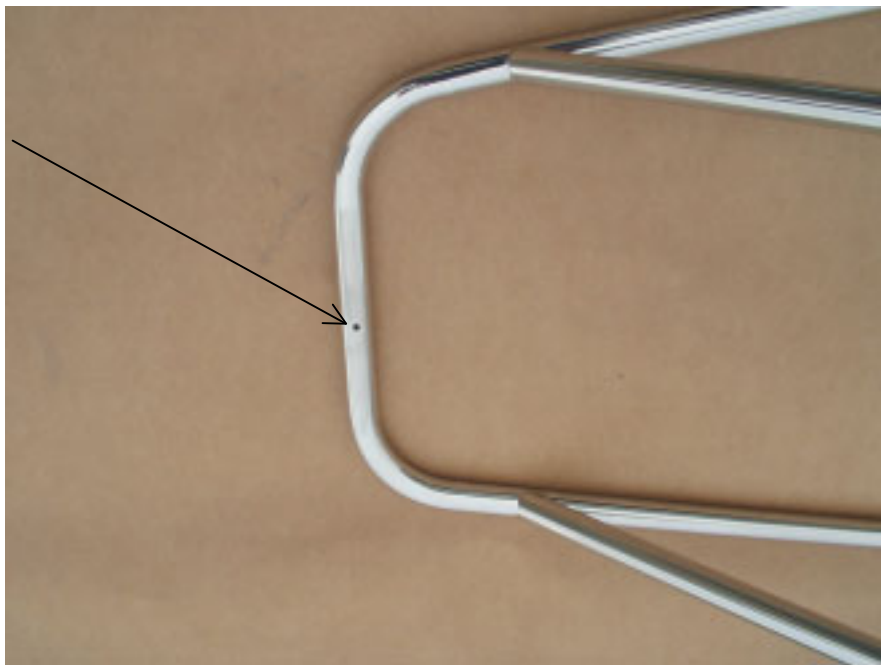
It has recently come to our attention there is a potential for water intrusion into the bow rail on Motor Yacht and Sport Bridge models. Water may be able to leak into the rails at the slip junction between the forward and aft sections. If excessive water builds up in the rail and freezes, the rail may burst or warp, causing significant damage. We are recommending that a small 1/4" diameter hole be drilled into the pulpit section to allow any water that leaks into the rail to drain out. The recommended location is on the underside of the bow pulpit rail, centered between the forward stanchions. Use care so that the hole is not drilled entirely through the rail. A photograph has been attached for further clarification.

Ø 1/4" Hole
Underside of rail,
centrally located
