**SILVERTON**

# SERVICE BULLETIN

**BULLETIN # 04-04**  
**DATE: 5/24/2004**  
**SUBJECT: 34 Convertible Exhaust Tube Clearance**

**HULL #s: 101 to 159**

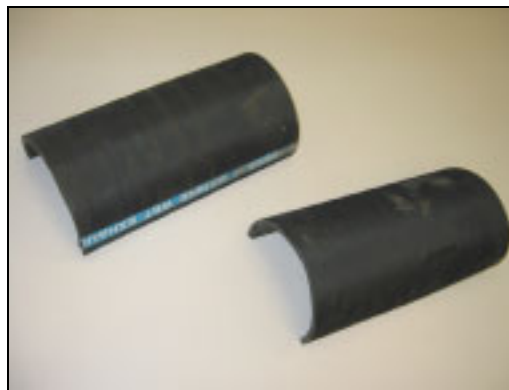
It has recently come to our attention that on some 34 Convertibles, there may be a problem with the main engine exhaust lines. On some installations, the FRP exhaust tube may be hitting on the underside of the cockpit floor. Over time, this may result in damage to and ultimate failure of the main engine exhaust lines. This can lead to a dangerous build-up of water, exhaust fumes, and carbon monoxide in the bilge of the boat.

- ∞ Open the cockpit hatch and remove the cockpit fish box.
- ∞ Using a flashlight, observe the exhaust tube on both the port and starboard side. Inspect the area to see if the tube is hitting the underside of the cockpit floor. The likely pinch point is approximately 3 ft. forward of the exhaust port
- ∞ Slice a 12" piece of soft-wall exhaust hose (5" on all gasoline boats and Yanmar 6LP-315Hp diesel boats, 6" on Cummins 330B diesel boats) in half lengthwise as shown in the photo below.
