**SILVERTON**

## SERVICE BULLETIN

**BULLETIN # 03-03**

**SUBJECT: 42 CONVERTIBLE STEERING CLEVIS PINS**

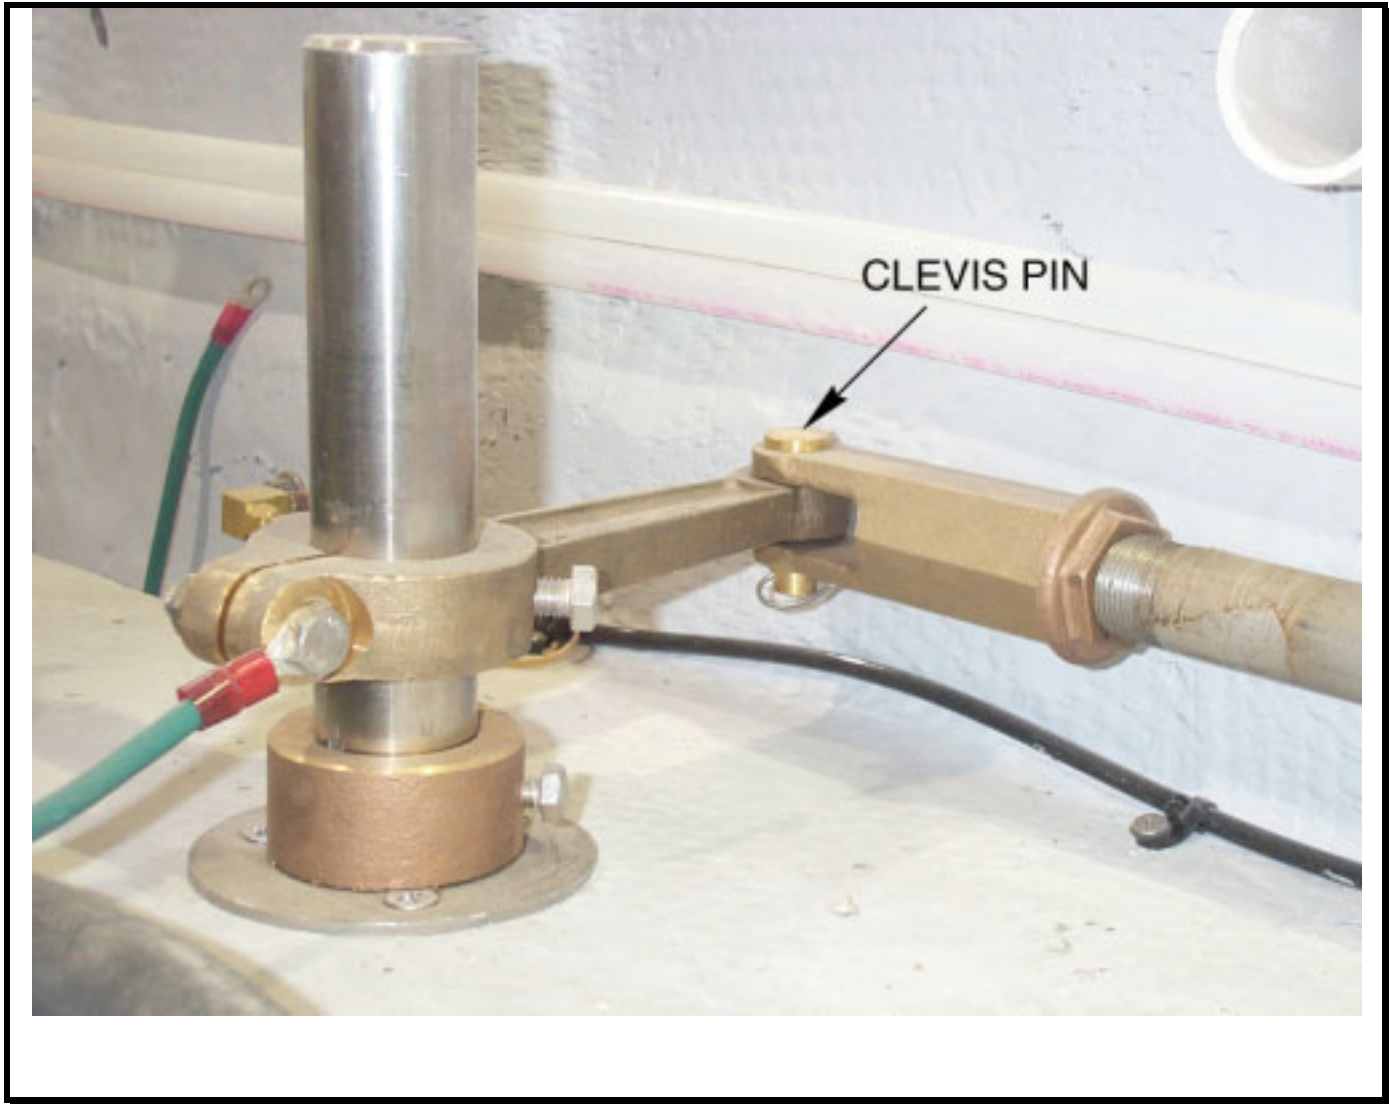
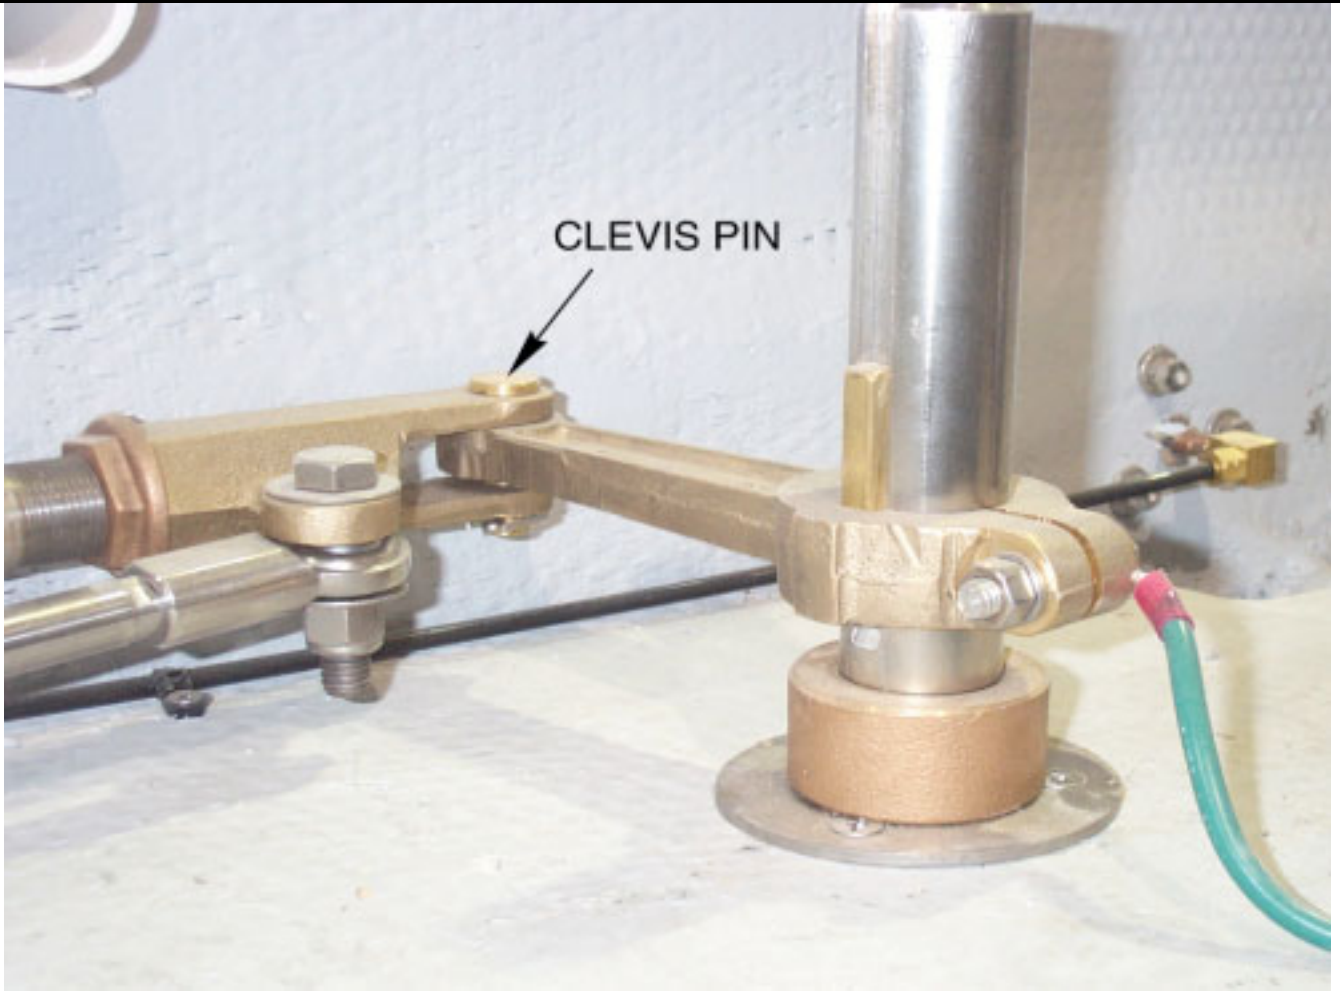
CLEVIS PIN

It has come to our attention that the steering clevis pins on certain 42 convertibles have shown excessive wear. Because this system has a large affect on the handling and performance of the boat we recommend the following repairs be done as soon as possible.

The original brass clevis pins need to be replaced by a new stainless steel clevis pin with a nylon bushing. All parts should be ordered thru the customer service department.

- 2 ea. Stainless clevis pins
- 2 ea. Nylon bushings
- 2 ea. 1 ¼ X 1/8" Cotter pin
