SILVERTON

SERVICE BULLETIN

BULLETIN: 02-06

SUBJECT: 43SB GALLEY AIR CONDITIONING DUCT HOSE

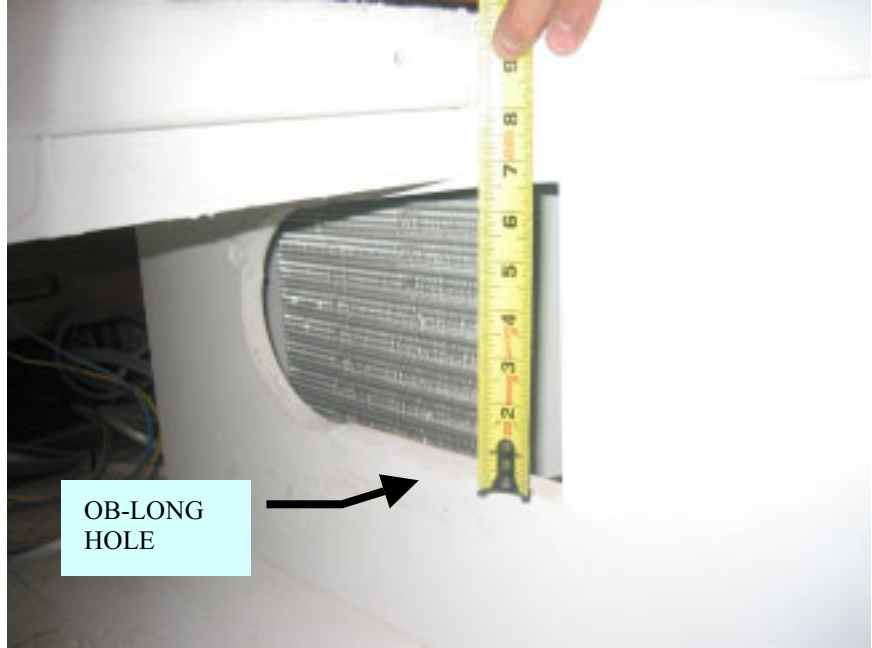
OB-LONG
HOLE

- 1- Remove air condition hatch located in the STBD. Mid state room.
- 2- Remove galley duct hose from air cond. unit and pull duct hose through into galley floor compartment. (See photo below)
- 3- With a jigsaw ob-long hole where duct hose passed through bulkhead so duct hose is inline with plenum box on air cond. unit. (See photo below) (Before cutting hole be certain that there are no hose or wires in area to be cut and the blade on saw will not hit the AC unit.)
- 4- Pass duct hose back through hole and re-attach to AC unit.

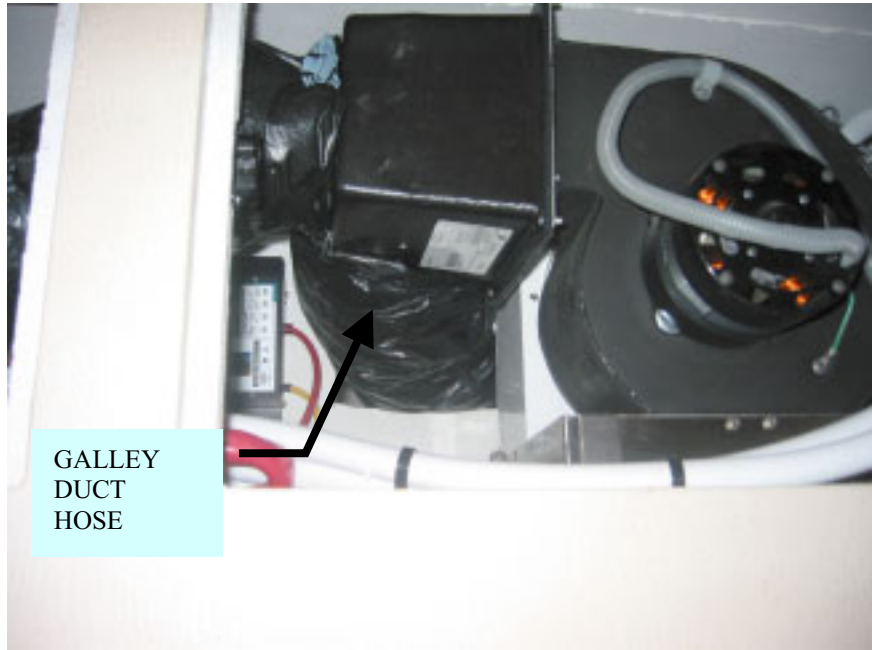
GALLEY
DUCT
HOSE
