# SERVICE BULLETIN

**BULLETIN:** 11-06  
**DATE:** 12-18-06  
**SUBJECT:** 48C and 50C Cabin Entry Door Lock

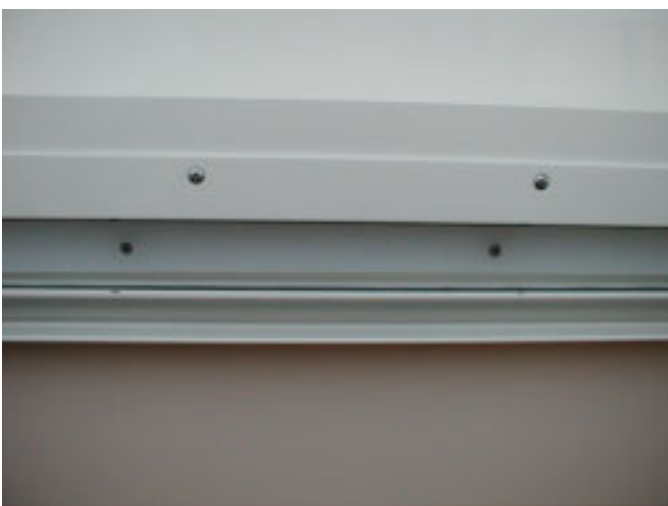
Photo #1

A plastic filler strip in the door track above the door may have not been installed. This filler strip prevents the door from being lifted out of the bottom track. If the filler is missing, it is possible to lift the door and gain access to the cabin even when the door is locked closed.

To determine if the filler is installed, look up into the top track to see a white or black plastic filler strip secured with screws. If the filler is missing, contact Silverton Customer Service for to obtain the filler and have it installed.
