SERVICE BULLETIN

BULLETIN: 05-06

SUBJECT: 33C Generator

HULL #s: 102, 103, 104, 106, 107, 109

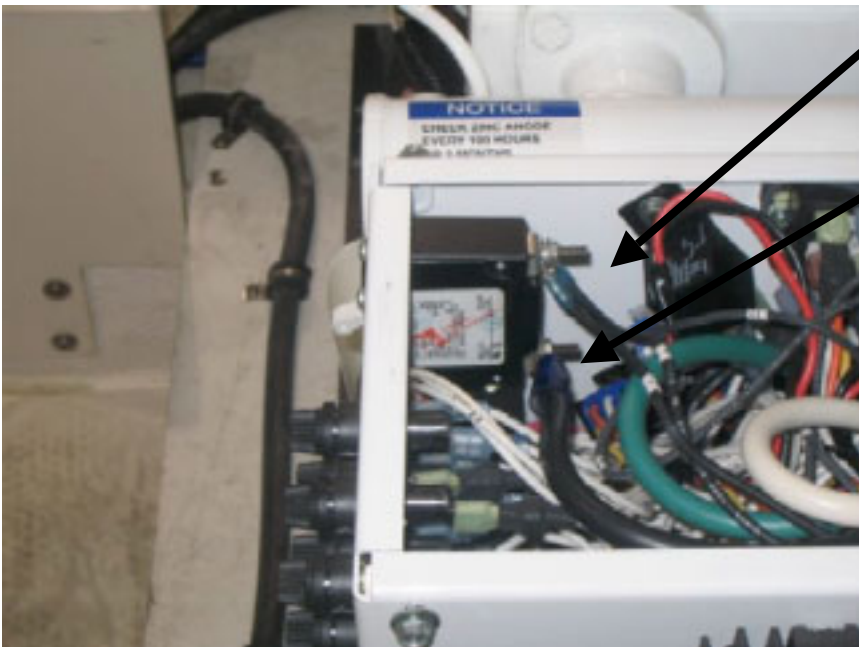
PHOTO 3

Breaker shown in this photo has the correct wiring.

NOTICE:
6 gauge black wire on bottom terminal of breaker. This is correct

- 1- Turn generator battery switch to the off position.
- 2- Turn generator main breaker at AC main panel to the off position.
- 3- With a 5/16" nut driver or wrench open sound shield. Remove left side, right side and top bolts of sound shield. (See photos 1-1A)
- 4- open lid to electrical box (see photo 2)
- 5- To determine if generator is wired correctly (see photo 3) 6 gauge black wire should be on load side of breaker by it self as in photo 3.
- 6- If generator is wired incorrectly as in photo 4, move 6 gauge black wire to load side of breaker as in photo 3

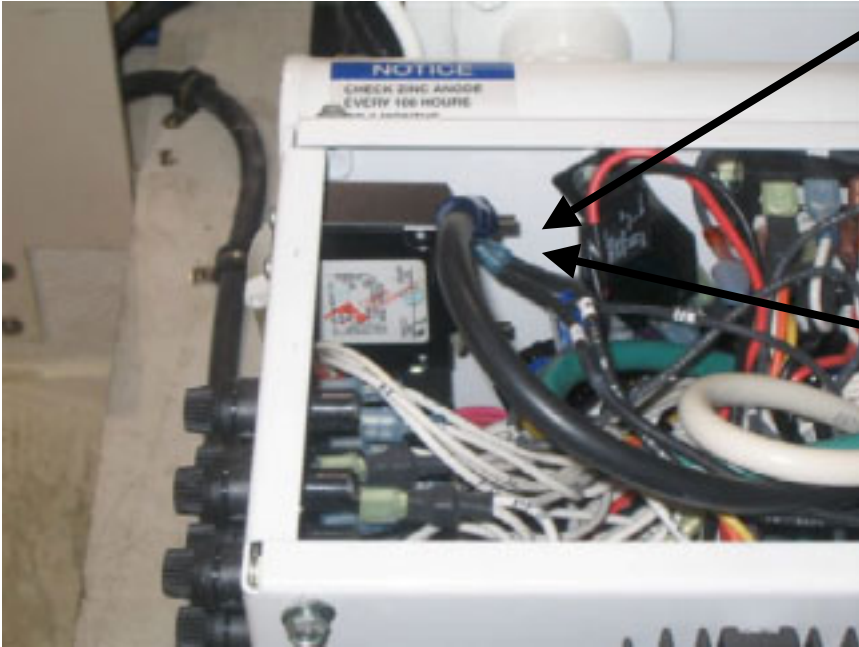
PHOTO 4

There is a possibility on 33 convertibles the generator main breaker was wired incorrectly. To verify if the generator is wired correctly follow steps below. Silverton will allow two hours labor to make this repair.

Breaker shown in this photo has the incorrect wiring.

NOTICE:
6 gauge black wire on top terminal of breaker. This is incorrect
