SILVERTON

SERVICE BULLETIN

BULLETIN # 02-03

SUBJECT: 43MY Washer / Dryer Vent Installation

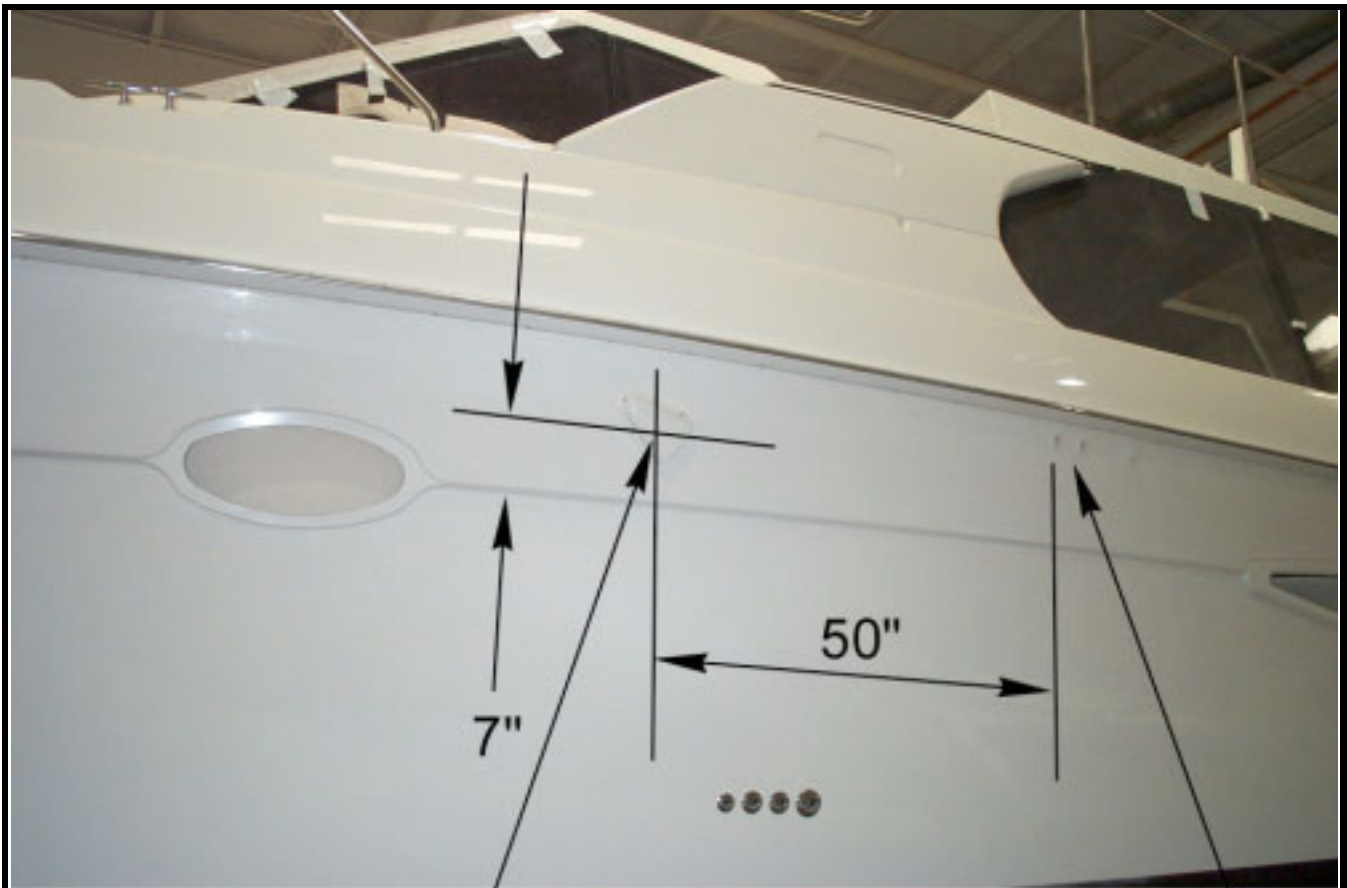
43 Motor Yacht Washer/Dryer Vent Location

We have discovered that the possibility exist that the dryer vent hose may not have been connected to an outside vent. Please check the port side of the boat for a vent as shown in the picture on page two. If no vent is visible, proceed with the following steps to install the vent.

3 7/8" Hole

Forward Waste Vent

The vent hose is to be located on the port side of the hull. See attached print for exact location of the 3 7/8" vent hole. After hole is cut, install clam shell cover on a 45° angled aft, centering it over the 3 7/8" vent hole. Use urethane sealant and #6 x 3/4 S/S Pan head screws to secure clam shell to hull. See attached print for proper installation.
